Advanced Technology Composite Fuselage—Materials and Processes

The Boeing Company • Seattle, Washington

This document is one of nine complementary final technical reports on the development of advanced composite transport fuselage concepts. The work described was performed by the Boeing Commercial Airplane Group, Seattle, Washington, from May 1989 through December 1995 under contracts NAS1-18889 and NAS1-20013, Task 2. The contracts were sponsored by the National Aeronautics and Space Administration, Langley Research Center (NASA-LaRC) as part of the Advanced Composite Technology (ACT) program. Direction from NASA-LaRC was provided by M.J. Shuart, J.G. Davis, W.T. Freeman, and J.B. Nelson.

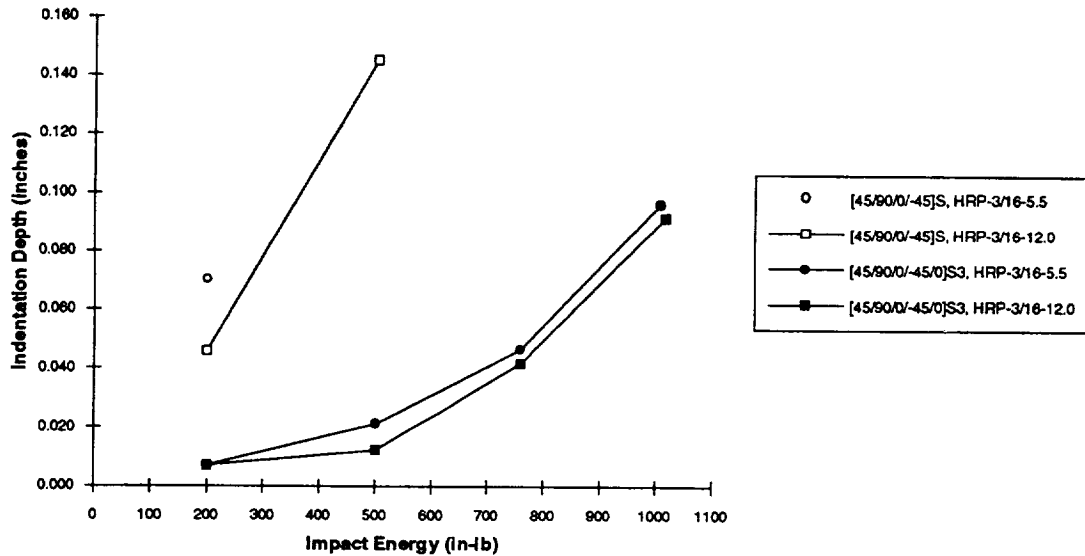
Figure G-7: *Effect of Facesheet Thickness on Indentation Depth in Composite Sandwich Structures.*

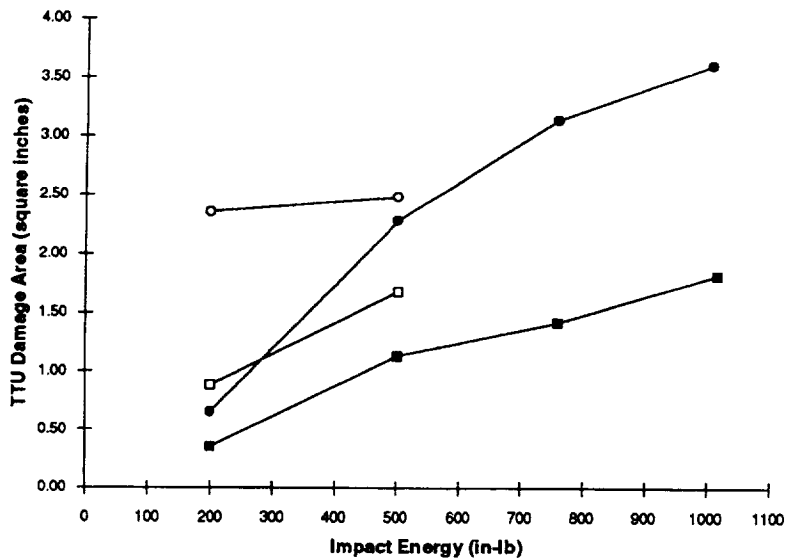
Figure G-8: *Effect of Facesheet Thickness on Damage Area in Composite Sandwich Structures.*
